U.S. CHEMICAL SAFETY AND HAZARD INVESTIGATION BOARD

INVESTIGATION REPORT

CATASTROPHIC VESSEL OVERPRESSURIZATION (4 DEATHS)

Sonat Exploration Company
Temple 22-1 Common Point Separation Facility
Pitkin, Louisiana
March 4, 1998

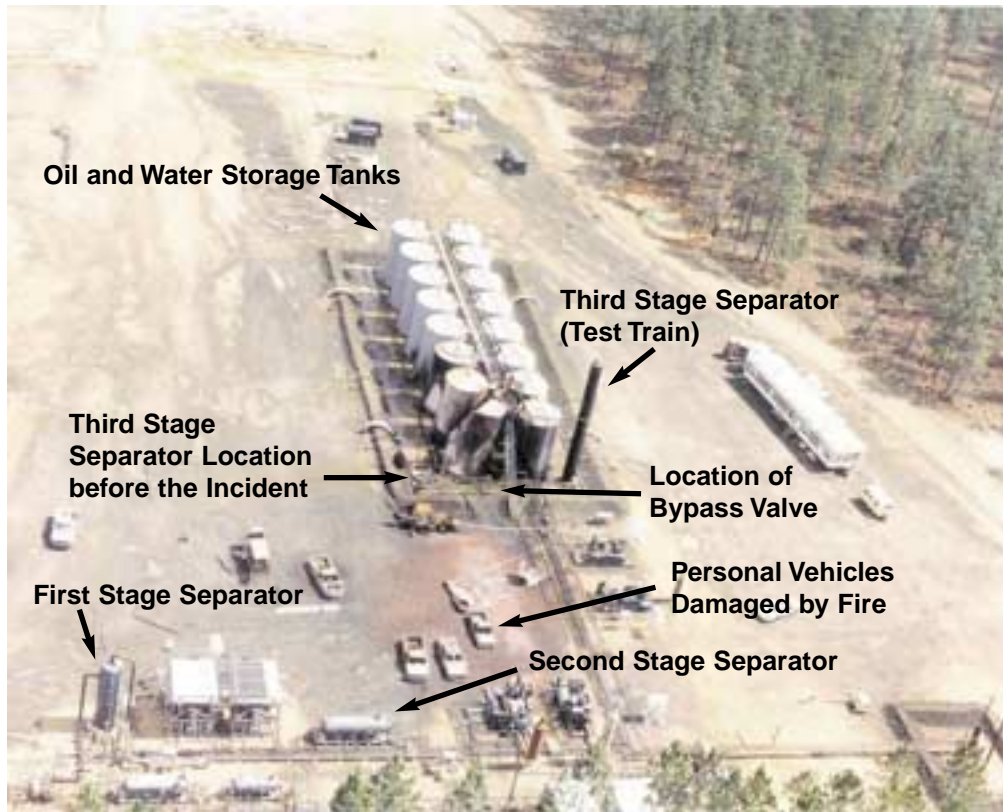
Figure 1. Aerial View of the Temple 22-1 Common Point Separation Facility after the Incident

In addition to the fatalities, the incident resulted in about \$200,000 worth of damage, including the destruction of the third-stage separator, four private vehicles, and a backhoe and damage to the facility storage tanks. Figures 1, 7, and 8 document the condition of the facility after the incident.

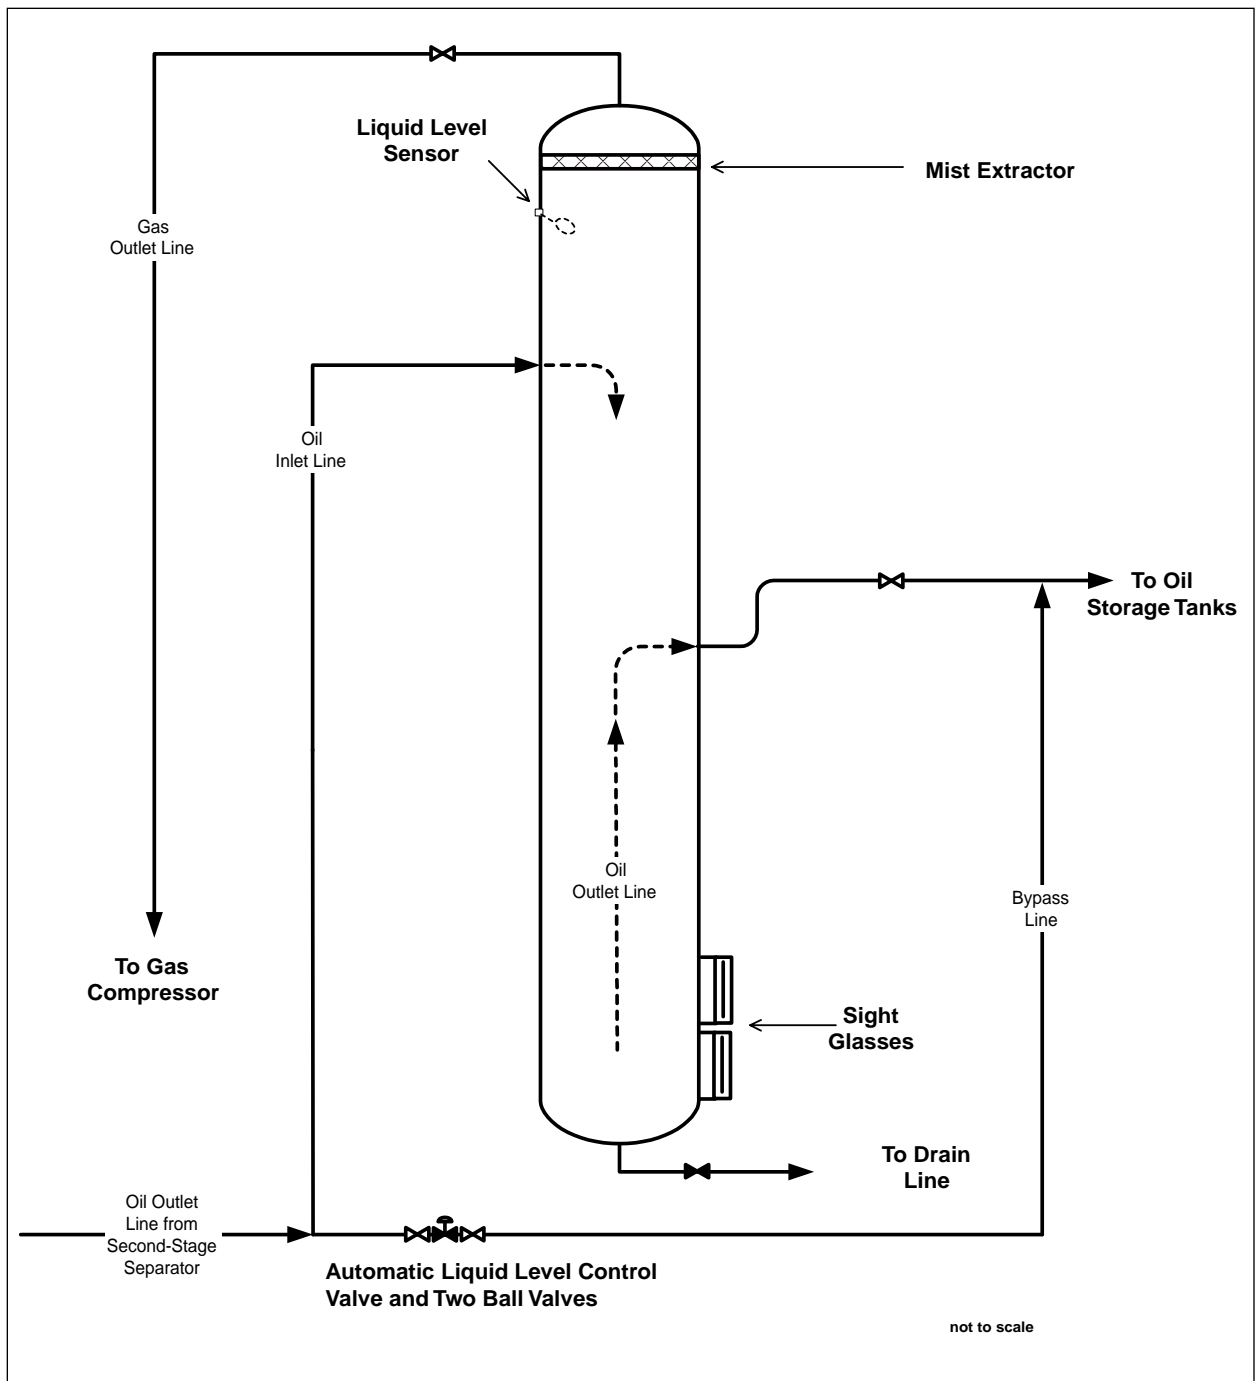
Figure 4. Third-Stage Separator Schematic

Each third-stage separator (Bulk and Test) was a 45-foot-tall vessel with a diameter of four feet (see Figure 4 for details). In operation, the vessel would be approximately 80% full with fluid. Well fluid was introduced into the separator at a height of approximately 35 feet, and separated

The third-stage separator was only rated for atmospheric pressure service (14.7 psia). Vessel failure was the result of overpressurization by purge gases and was both sudden and catastrophic. Four personnel were within 40 feet of the third-stage separator at the time it ruptured.²⁷

Prior to operating the Bulk Train, the third-stage separator should thus have been equipped with a pressure-relief system, as recommended by API consensus guidance.³³

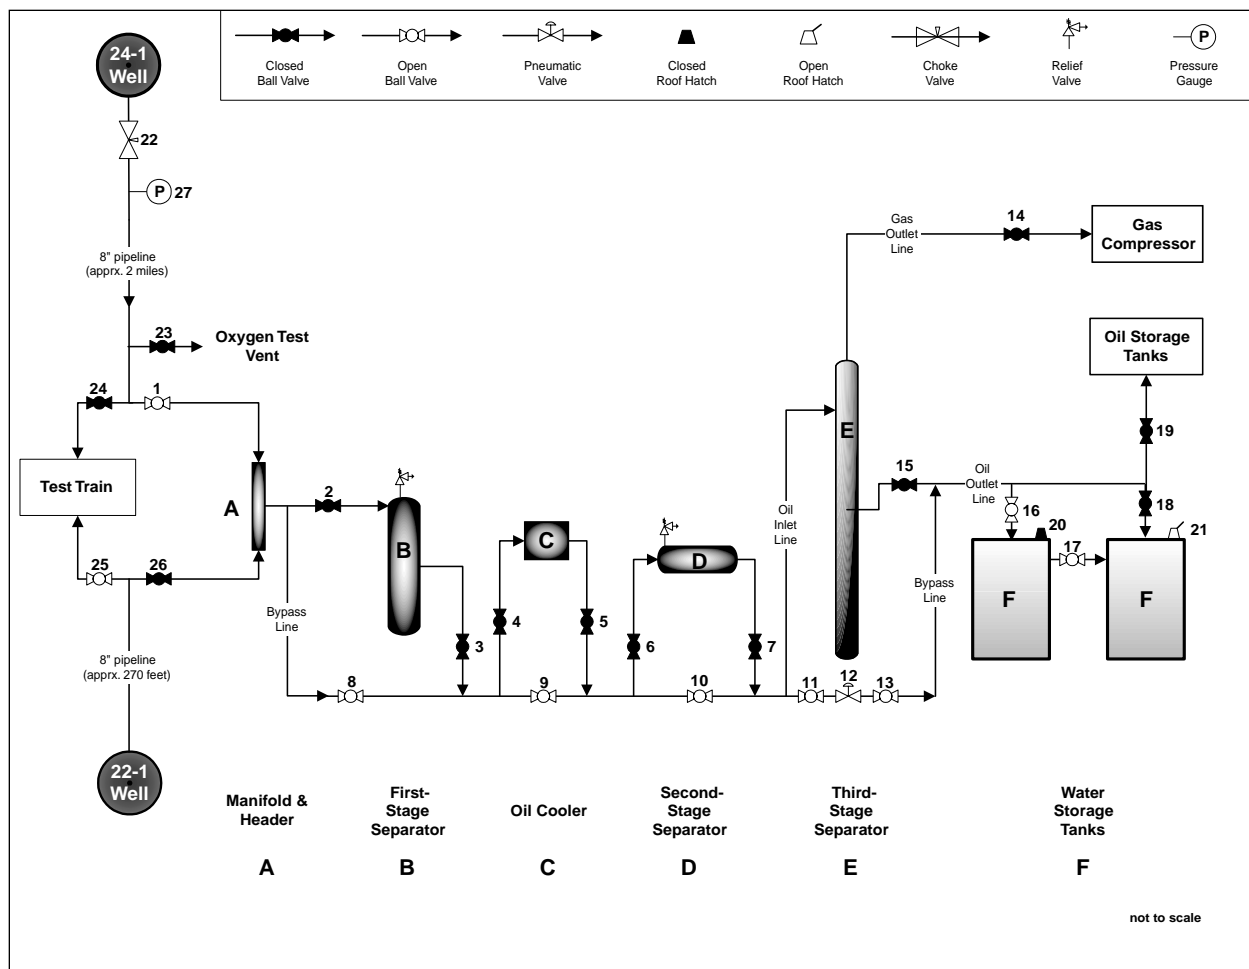
Figure 5. Intended Valve Positions after the Final Alignment

Executing the plan required at least 11 valves to be manually repositioned, an activity that was performed without written procedures or valve position checklists. While most valves were manually operated ball valves,²² valve **12** was a pneumatic valve actuated by a liquid level probe located inside the third-stage separator. A high liquid level within this vessel would automatically cause valve **12** to open, allowing fluid to bypass the separator provided that the adjacent manual ball valves **11** and **13** were open. On the morning of March 4, workers had disconnected the supply of control gas to valve **12**, causing the valve to remain open thereafter.

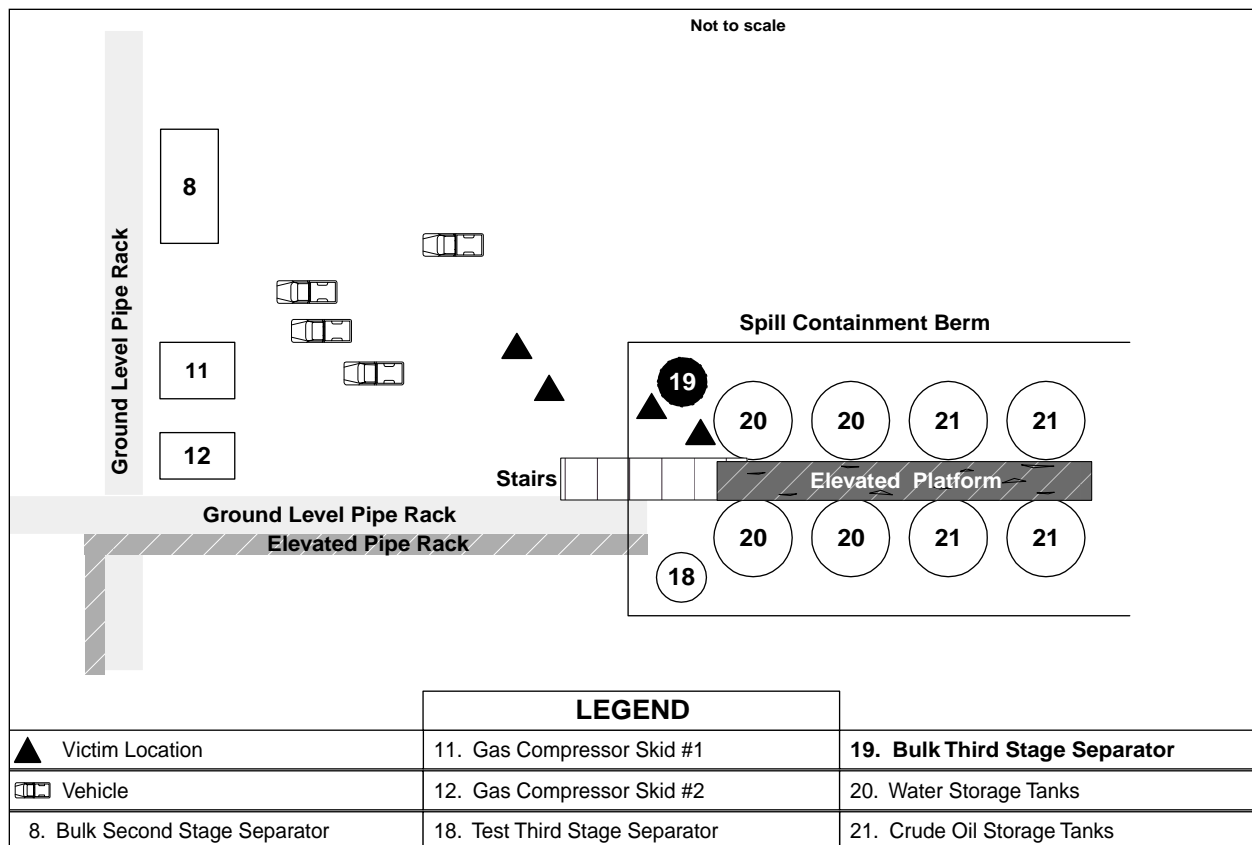
Figure 6. Locations of the Four Victims Found after the Incident

All four operators who were near the separator at the time of the failure were killed at once; in each case the cause of death was severe blast injuries. Figure 6 shows the approximate locations of the four victims, as found after the incident. The operator stationed near the header, about 190 feet from the separator, was thrown about five feet by the blast, and the construction supervisor was severely jolted as he exited his truck over 300 feet away at the pipeline valve. Both survived without serious injury.

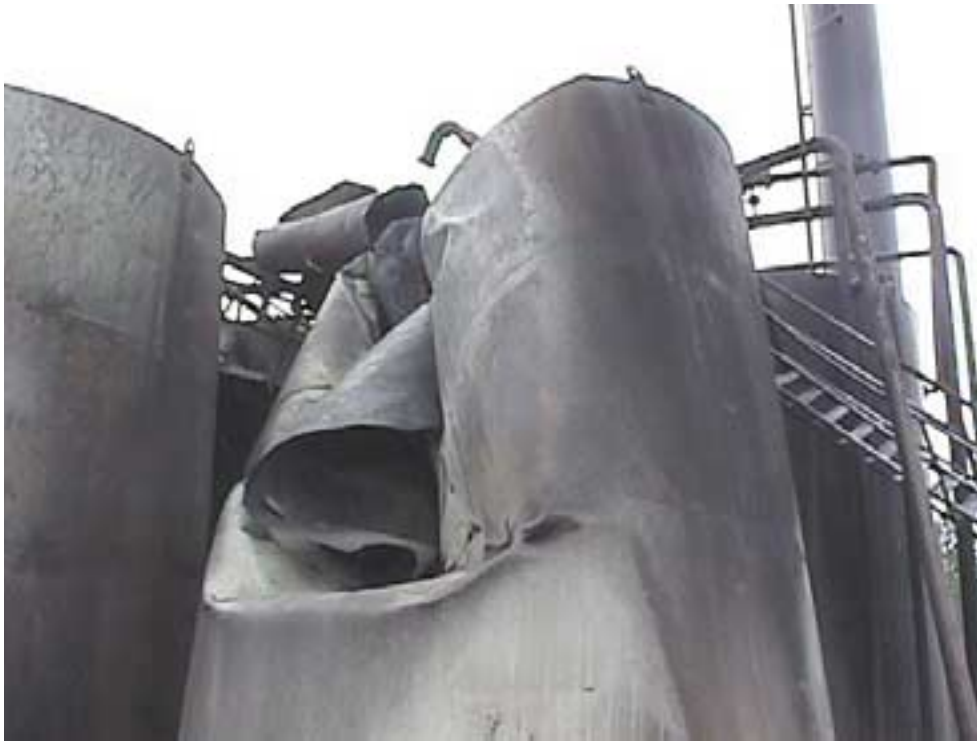
Figure 8. Damaged Water Storage Tank with Fragment of Third-Stage Separator

At approximately 6:15 p.m., the Bulk Train third-stage separator experienced a catastrophic failure. Gas from the ruptured separator immediately ignited, producing a large fireball centered over the location of the separator. Additional fires were ignited, fueled by natural gas leaking from the damaged storage tanks and piping.

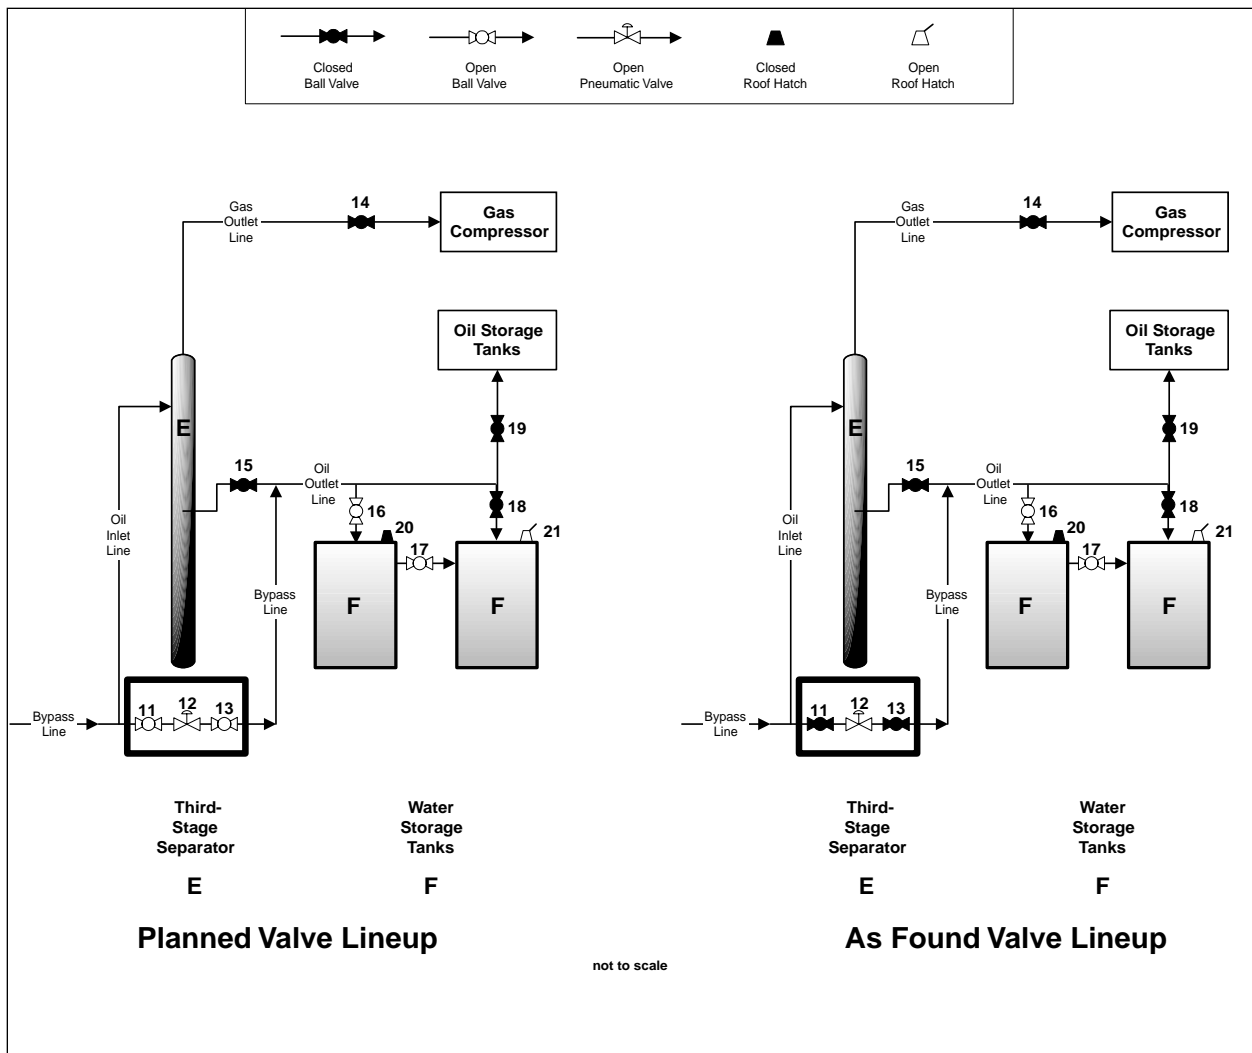
Figure 9. Comparison of Valve Alignments as Planned and as Found after the Incident

Soon after the fires stemming from the incident had been brought under control, Louisiana State Police inspected the area around the failed separator. They were accompanied by the Sonat production and construction supervisors. It was then discovered that, in contrast to the planned valve alignment, valves **11** and **13** were actually in the closed position.

Similarly, the timing of the closure of valves **11** and **13**, which triggered the vessel failure, could not be absolutely determined.²⁸ These two valves were opened in the morning but then closed early in the afternoon prior to the purging of the Bulk Train separators. The valves were not continuously monitored during most of the day. It is possible that the valves were not reopened as intended prior to the final purging process, and remained closed until vessel failure finally occurred. Alternatively, the valves may have been correctly opened during the final valve alignment, only to be manually closed later. However, no surviving personnel reported seeing the valves closed during any part of the final purging process, and there was no operational reason to close the valves once the purging was under way. The surviving supervisors did not report giving any such instruction, nor were any Bulk Train valve realignments whatsoever planned during the final purging process. Valves **11** and **13** were not intended to be closed once the Bulk Train entered routine production.²⁹
