**INVESTIGATION INTO THE CAUSES
OF THE FIRE OF FEBRUARY 23, 1999
AT NO. 50 CRUDE UNIT
TOSCO AVON REFINERY**

**PRELIMINARY REPORT TO THE
CONTRA COSTA COUNTY BOARD OF SUPERVISORS**

Contra Costa Health Services

July 28, 1999

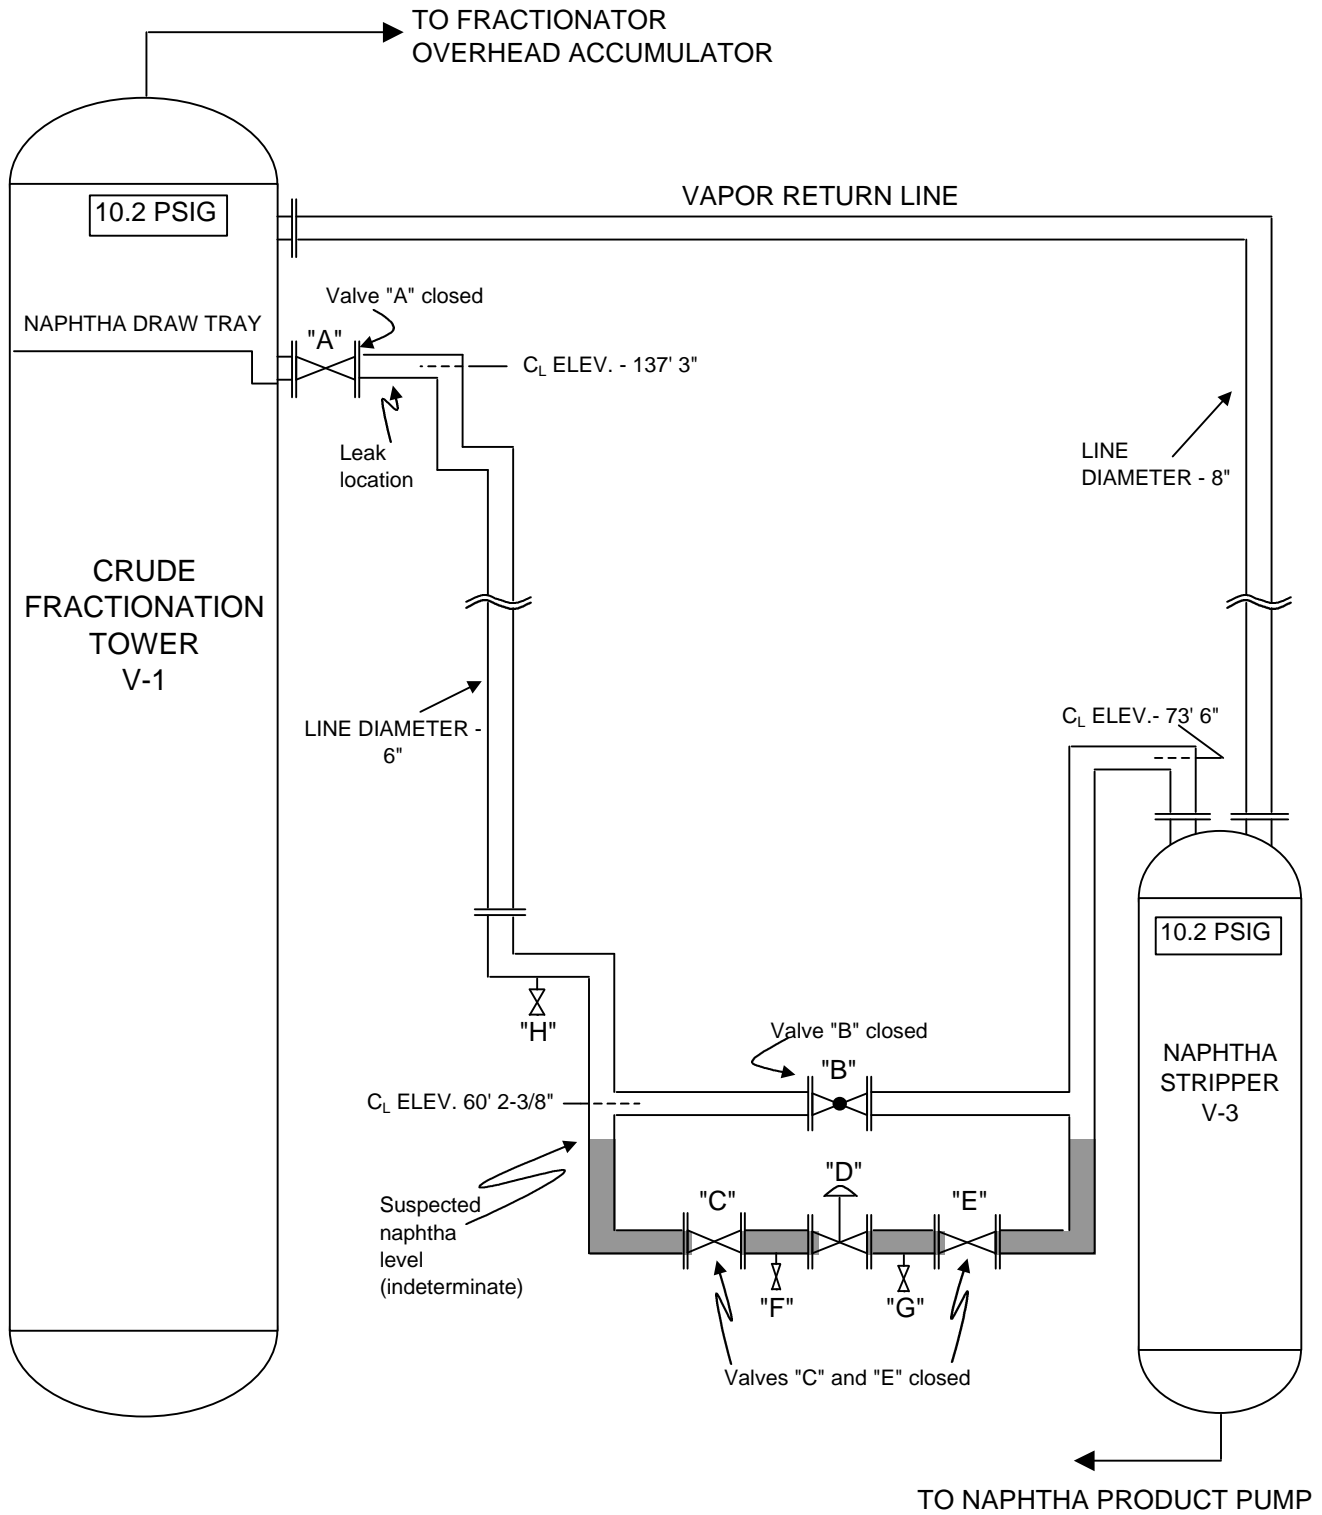
EXHIBIT - 1A
SUSPECTED SITUATION OF NAPHTHA LINE AFTER LEAK ON FEBRUARY 10TH

Exhibits 1A, 1B, and 1C show the naphtha levels assumed by various people at Tosco after the valves were closed on February 10th. Some at Tosco assumed a low naphtha level in the piping as shown in Exhibit 1A. Some assumed the “sink trap” level of Exhibit 1B and others thought the level was high as depicted in Exhibit 1C. However, the actual level was never determined before the fire. The Maintenance Supervisor was observed hammering on the line during the week of February 15th trying to determine the liquid level in the line. Exhibit 2 shows the actual naphtha level that had to be in the line after Valve A was closed after the leak of February 10th.

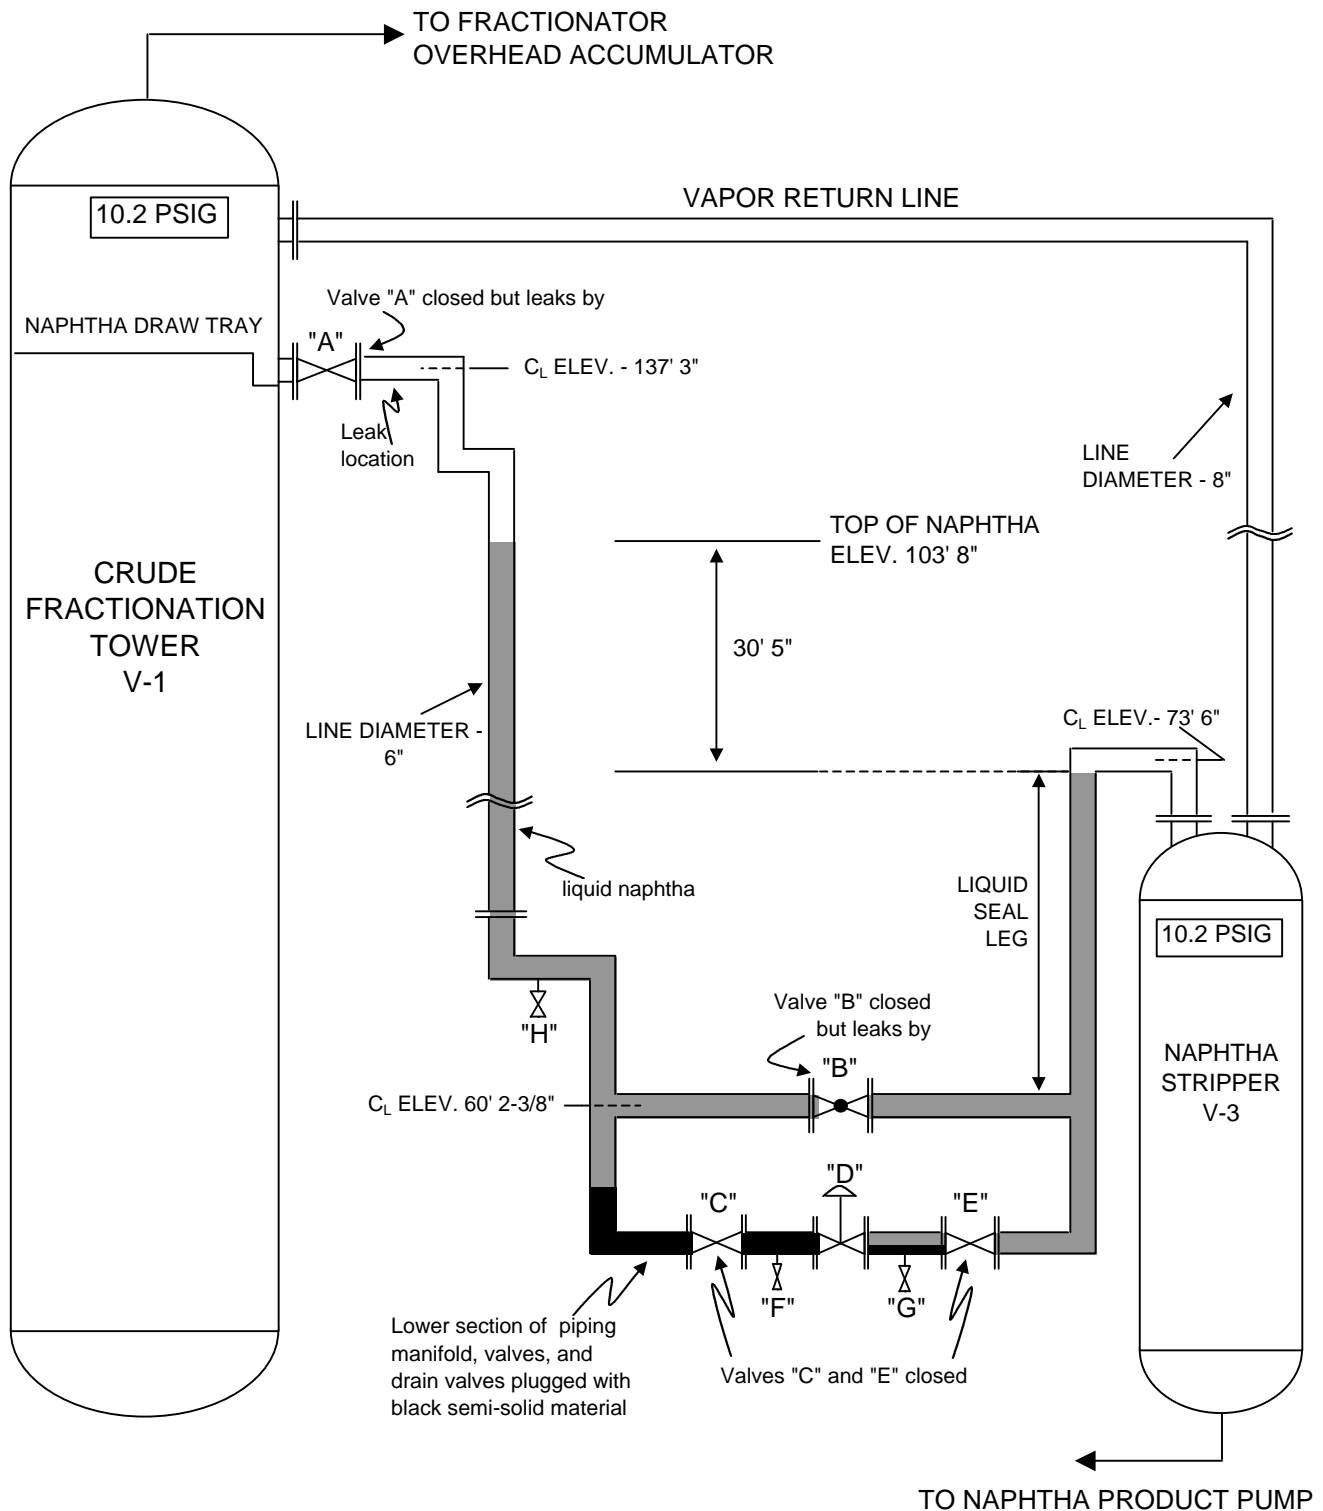
EXHIBIT - 2
ACTUAL SITUATION OF NAPHTHA LINE AFTER LEAK OF FEBRUARY 10TH

The naphtha piping runs from Fractionator to the Naphtha Stripper as shown in Exhibit 2 (all exhibits are in Appendix A). After Valve A was closed to stop the leak, the piping remained about 70% full. The line remained 70% full due to the “U” shaped liquid trap formed by the bottom of the piping, and the fact that the pressure in the operating Naphtha Stripper supported (pushed up) a vertical leg of naphtha in the piping next to the Fractionator. The naphtha was physically released from the piping as follows: Following unsuccessful attempts to drain the line before starting to dismantle it, Tosco workers cold cut and removed the top section of the piping above the liquid level (Exhibit 5). Tosco workers then initiated a second cold cut below the liquid level that leaked naphtha. Tosco workers then began draining the line from a flange as shown in Exhibit 6. Valve B leaked badly, though this was not known on February 23rd. Consequently, as naphtha was being drained, the level of the vertical leg of naphtha next to the Naphtha Stripper dropped. This vertical leg was a liquid seal that prevented naphtha vapors from

Valve A ended the February 10th leak incident and is the starting point of the CCHS scope of investigation into the causes of the fire on February 23, 1999. After Valve A was closed, only about 30% of the naphtha in the piping between the Fractionator and the Naphtha Stripper could drain into the Naphtha Stripper. Drainage was limited to 30% because of the configuration of the piping and because the Naphtha Stripper was still at operating pressure. The piping configuration is such that the piping from the Fractionator goes to a low point before rising into the Naphtha Stripper. This configuration forms a “U” shaped liquid trap (like a kitchen sink trap) that contained naphtha to the level of the Naphtha Stripper inlet. In addition, the pressure in the Naphtha Stripper supported (pushed up) a vertical column of naphtha 30 to 31 ft. above the liquid trap level. This situation is shown in Exhibit 2. After Valve A was closed, operators closed Valves B, C, and E.

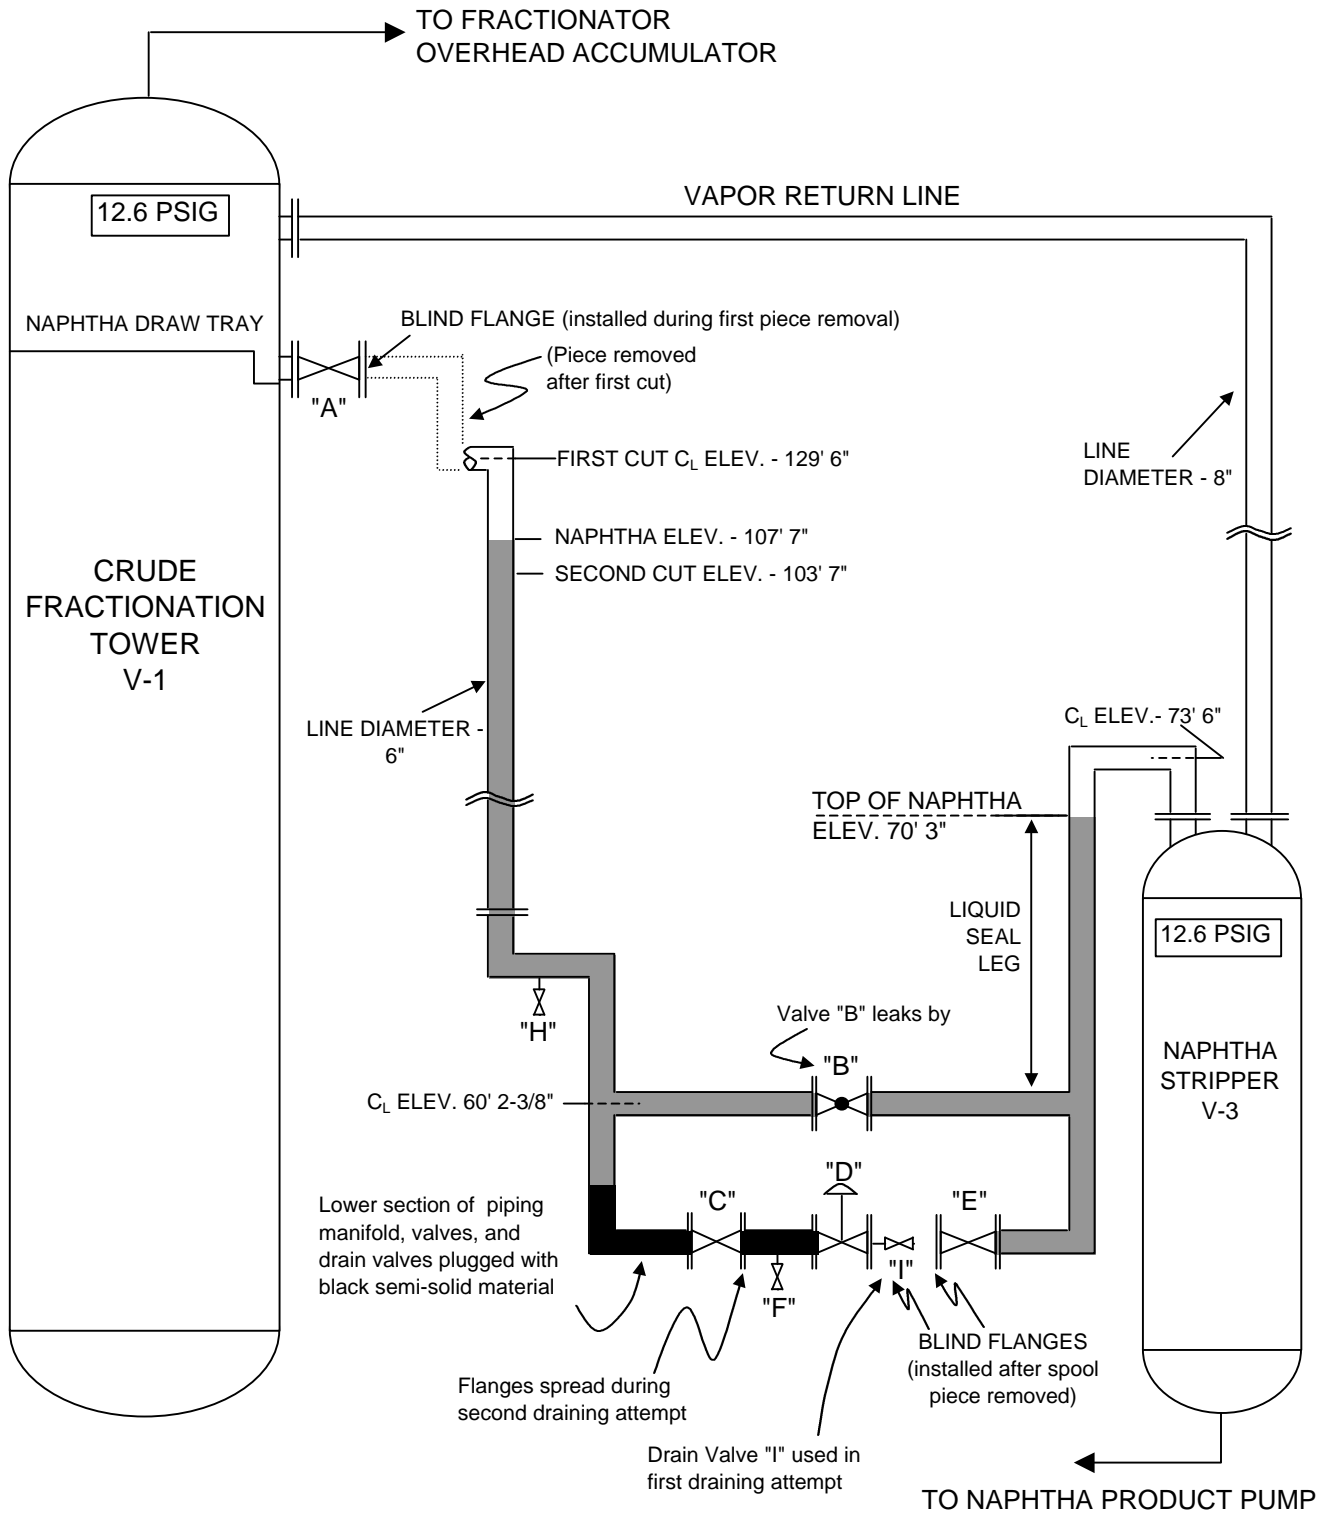
EXHIBIT - 5
LOCATION OF FIRST AND SECOND COLD CUTS AND NAPHTHA LEVELS BEFORE
INITIATION OF DRAINING ATTEMPTS

From approximately 9:00 AM to 9:30 AM, the operators and maintenance mechanics again attempted to drain the piping from the same location as the previous week; this time through an unplugged drain Valve "I" (See Exhibit 5) downstream of the control valve into a half barrel with a hose in the barrel connected to the vacuum truck. During this attempt, the No. 1 Operator in the field had an operator in the control room operate the control valve to various open positions in an attempt to start drainage. This attempt failed.

The Bigge foreman attached a cable from the crane to the piece of pipe to be removed and cold cutting was initiated (see Exhibit 5). At the same time the bolts were removed from the flange connecting Valve A to the piece of pipe and the flanges were separated. (It is possible that when no leakage occurred when these flanges were separated, the workers considered this as evidence that bypass Valve B was not leaking. If so, this was a false sense of security because bypass Valve B could have been wide open and there would have been no leakage at the first cut due to the liquid seal leg.) As can be seen in Exhibit 5, the first cold cut was made about 25 ft. above the level of naphtha in the pipe. During the cold cutting the line was pulled away from Valve A

After the first cold cut was complete, the No. 1 Operator, Maintenance Supervisor and a maintenance mechanic returned to the control valve and cracked open the downstream flange on Valve C (See Exhibit 5), and nothing drained. (The rest of the group remained on the tower in the vicinity of the second cut.) The Maintenance Supervisor next probed between the flanges with a gasket scraper, but still nothing drained. (Post incident investigation revealed that the piping at the bottom of the “U” was essentially plugged solid as indicated in Exhibit 5).

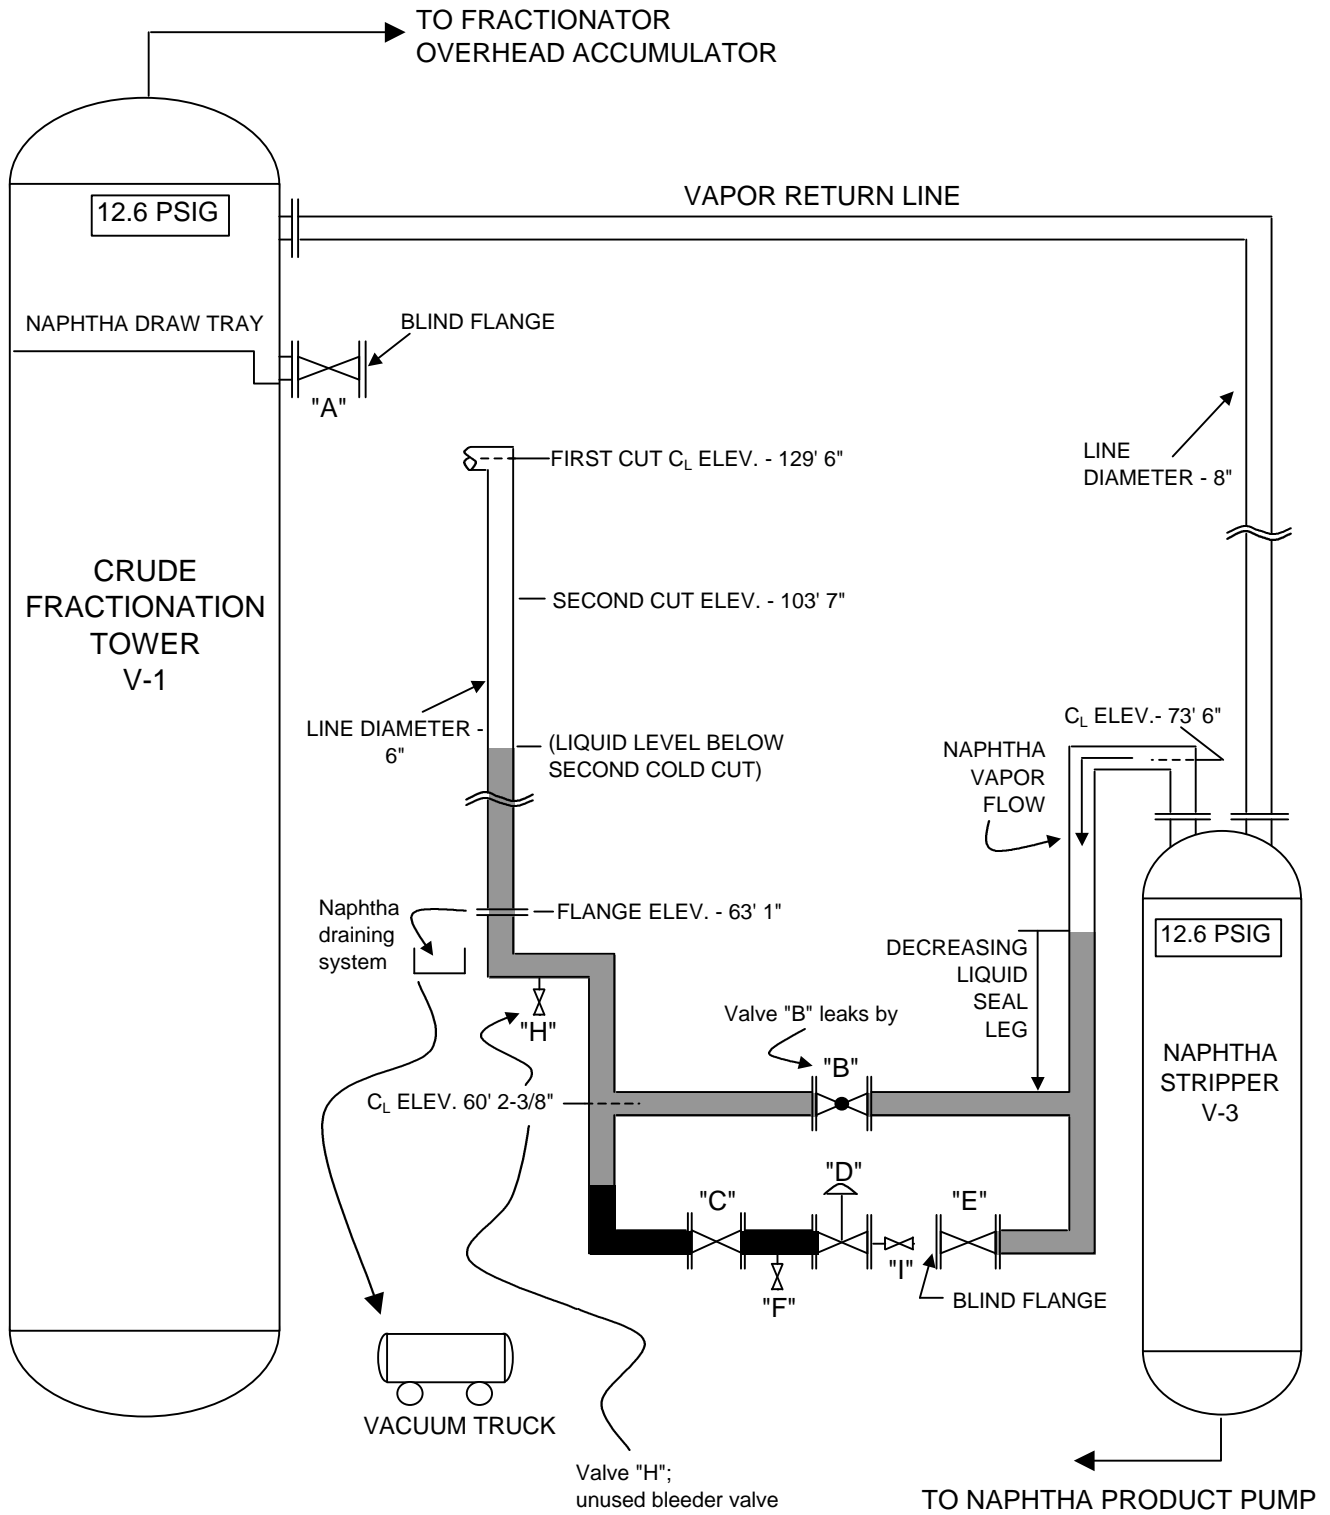
EXHIBIT - 6
TYPICAL SITUATION WHILE MAKING SECOND COLD CUT AFTER INITIATION OF THIRD DRAINING ATTEMPT

drain the line after lunch by spreading the flanges at the bottom of the vertical leg of piping as shown on Exhibit 6. At this time the workers all went to lunch. Before lunch, the maintenance mechanic sent for the leak clamp returned and was seen starting to climb up the Fractionator with the clamp. It is not known whether or not he installed the clamp before he took his lunch break.

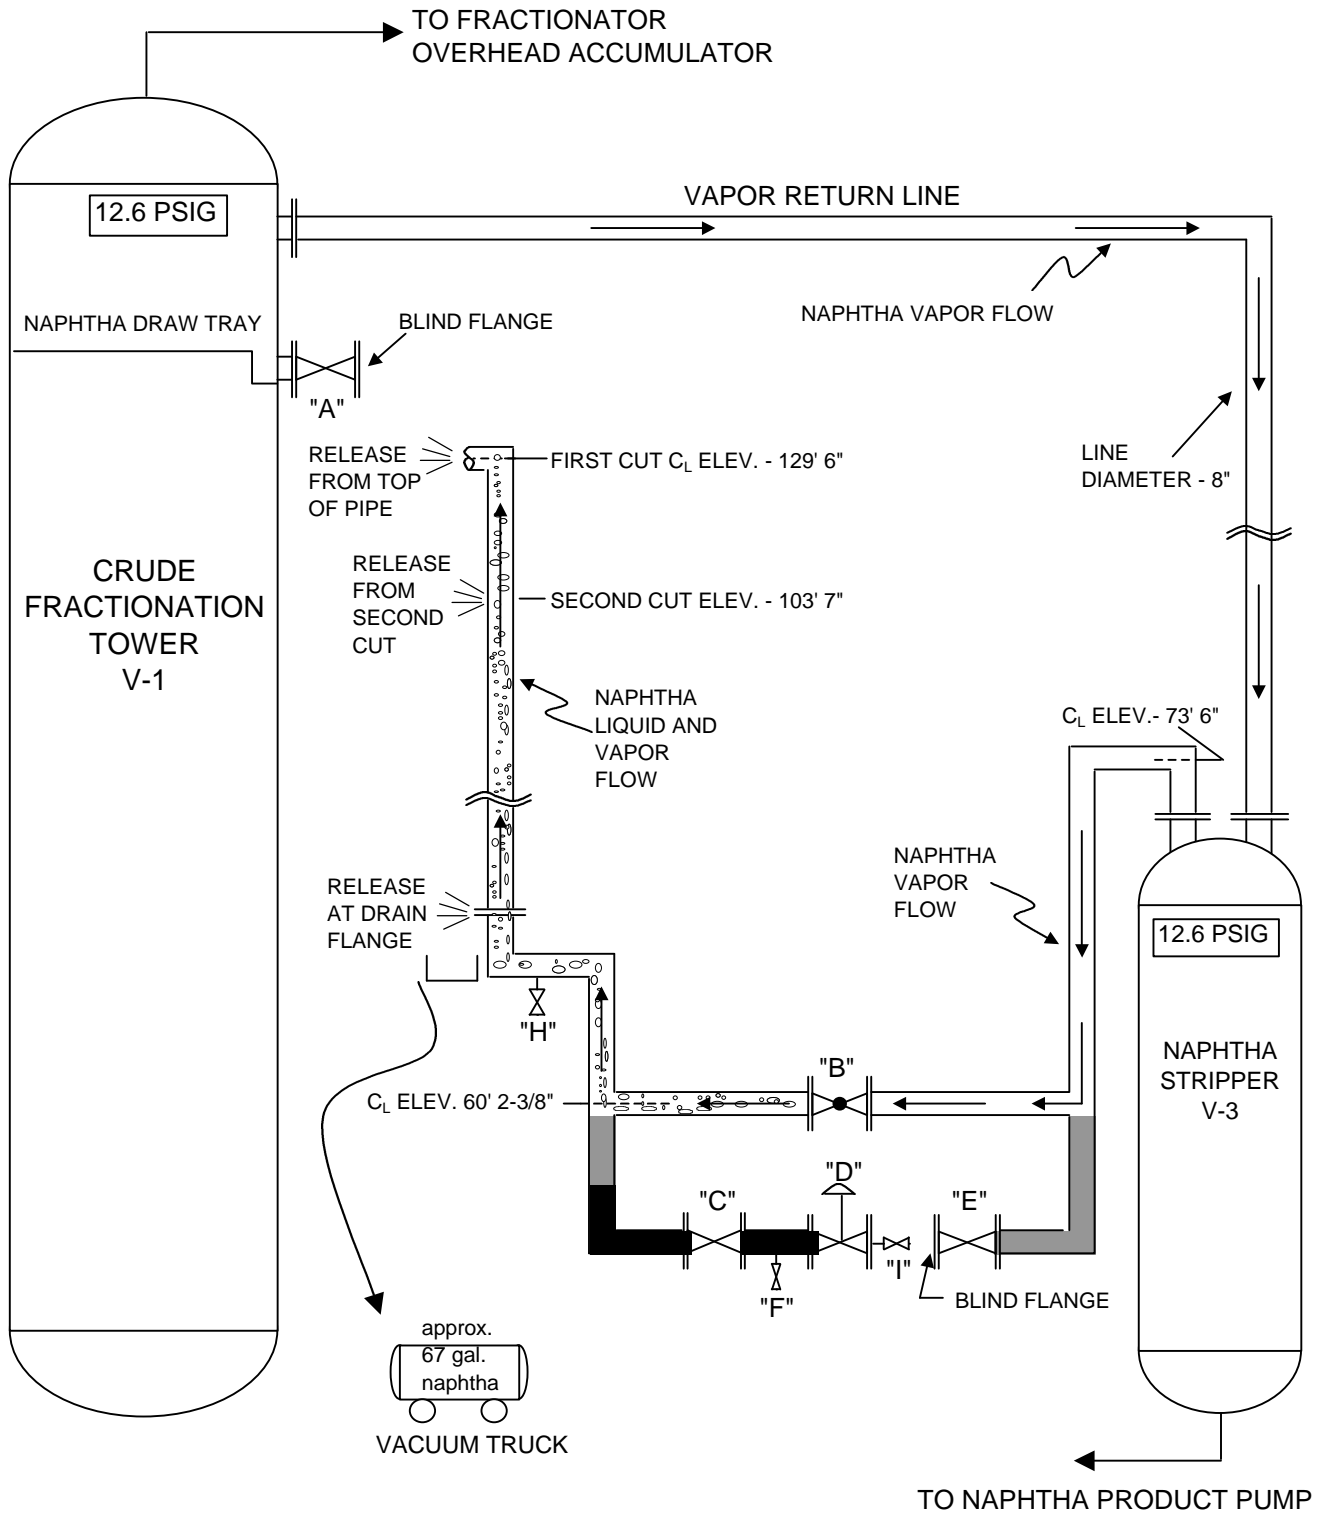
EXHIBIT - 8
RELEASE OF NAPHTHA RESULTING IN FIRE

the Naphtha Stripper flowing through Valve B. When sufficient naphtha was drained, the liquid seal was broken, naphtha vapors flowed through Valve B mixing with and lifting naphtha liquid up and out of the piping next to the Fractionator (Exhibit 8). The naphtha ignited off hot Fractionator surfaces.
