INVESTIGATION REPORT

THERMAL DECOMPOSITION INCIDENT

BP AMOCO POLYMERS, INC.

REPORT NO. 2001-03-I-GA

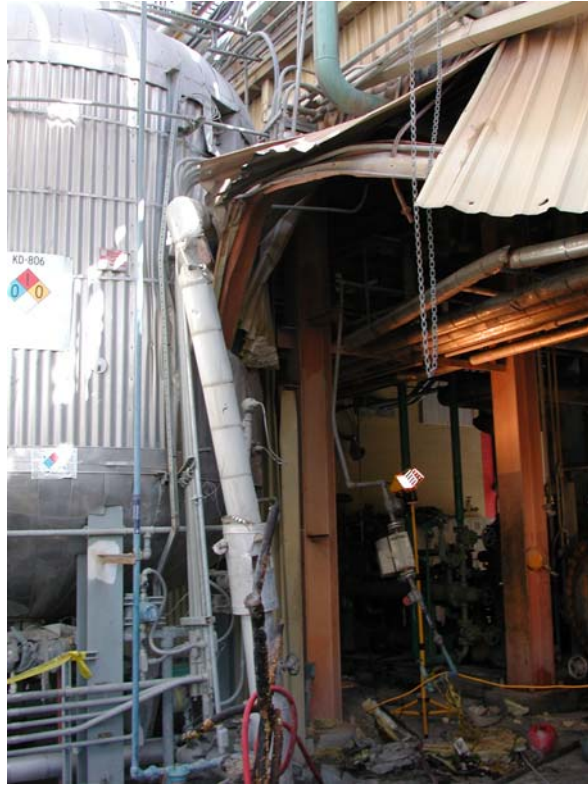
Figure 5. Damaged girder.

The cover was found 14 feet from the polymer catch tank. A girder for a canopy that sheltered the catch tank and extruder was torn from its structural members. The cover probably struck the girder as it blew off the tank. Examination of the cover suggested that it was bent by the pressure that caused the bolts to

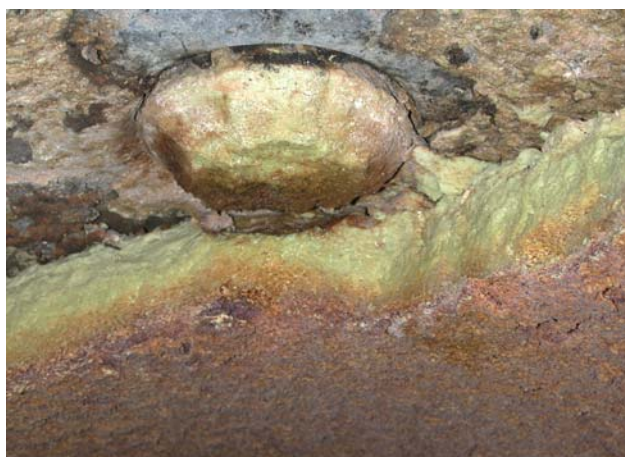
Figure 7. Polymer plugging the polymer catch tank vent nozzle.

Investigators found that most of the contents of the polymer catch tank were expelled in the incident. A solid layer of polymer 3 to 5 inches thick remained in the vessel and coated the entire inside surface, including the rear cover (see cover photograph). The vessel nozzles, including the vent nozzle, were completely plugged with polymer (Figure 7). Significant amounts of polymer were found in the vent system. Appendix A provides a more extensive discussion of the physical evidence.

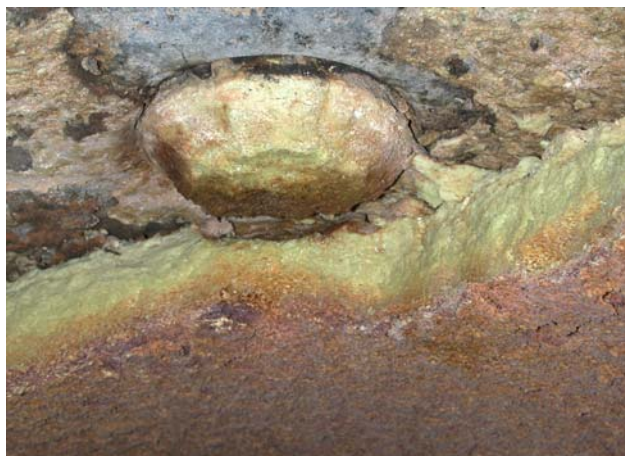
Figure A-1. Polymer plugging the polymer catch tank vent nozzle.

Most of the polymer catch tank contents was expelled, including the metal frame. A solid layer of polymer 3 to 5 inches thick, predominately yellow, remained in the vessel and coated the entire inside surface (see cover photo). Although the layer contained some bubbles and voids, it was composed of relatively dense material. Polymer was extruded into all the vessel nozzles, and they were completely plugged at the inlet (Figure A-1).

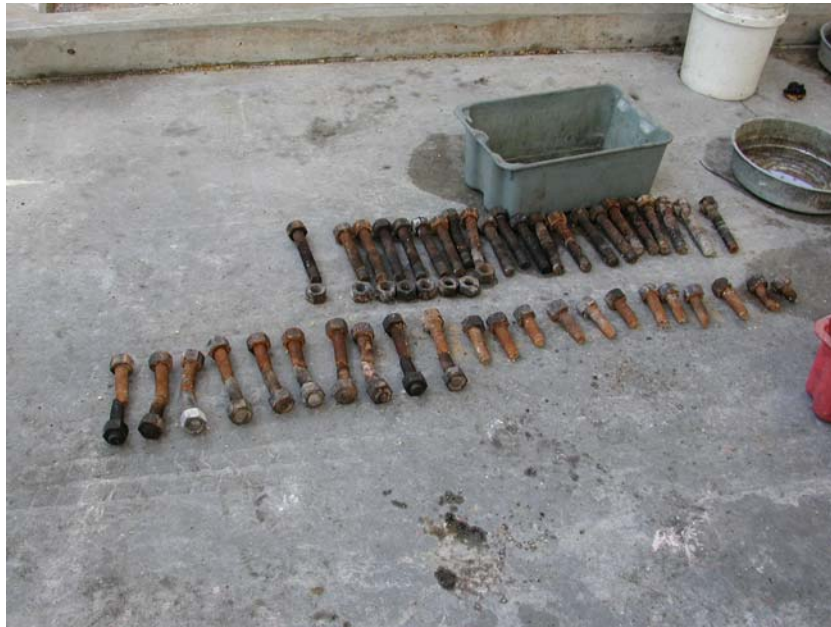
Figure A-2. Failed bolts from polymer catch tank cover.

break. Half of the 44 bolts were still in place at the time of failure; all were recovered (Figure A-2). Examination of the bolts revealed a combination of failure modes—ductile (i.e., thinning before breaking) and shear (i.e., rapid overload). None of the studs separated from the nuts. The drain valve attached to the cover was found in the closed position.

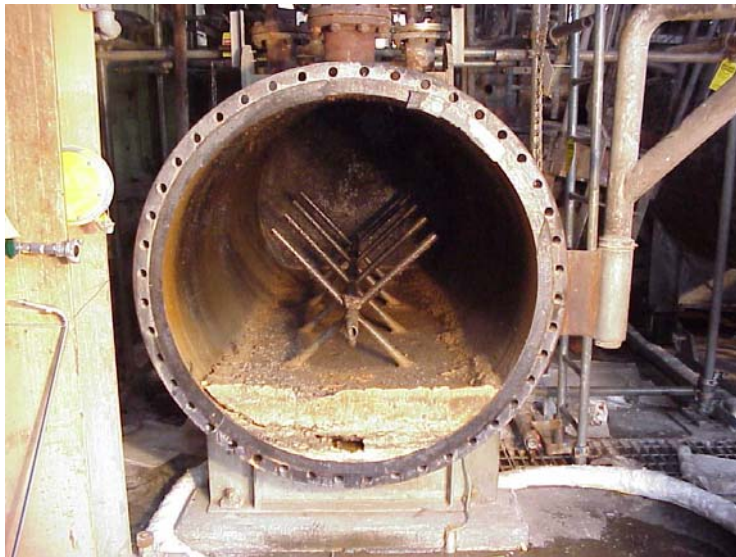
Figure A-3. Reactor knockout pot with internal frame visible.

The reactor knockout pot was not opened until April 17, 2001, to allow time for a hazard analysis and development of a safe work plan. Once opened, the vessel was found to be largely empty except for a 6-inch layer of material on the bottom (Figure A-3).

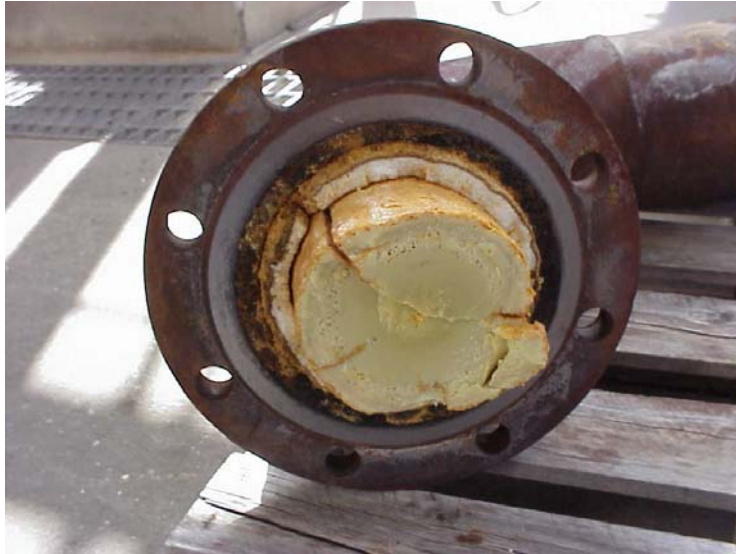
Figure A-4. Vent line obstructed by polymer layers.

The tap⁴³ to the pressure gauge on the 6-inch vent line was observed to be clear despite extensive plugging of the line itself.

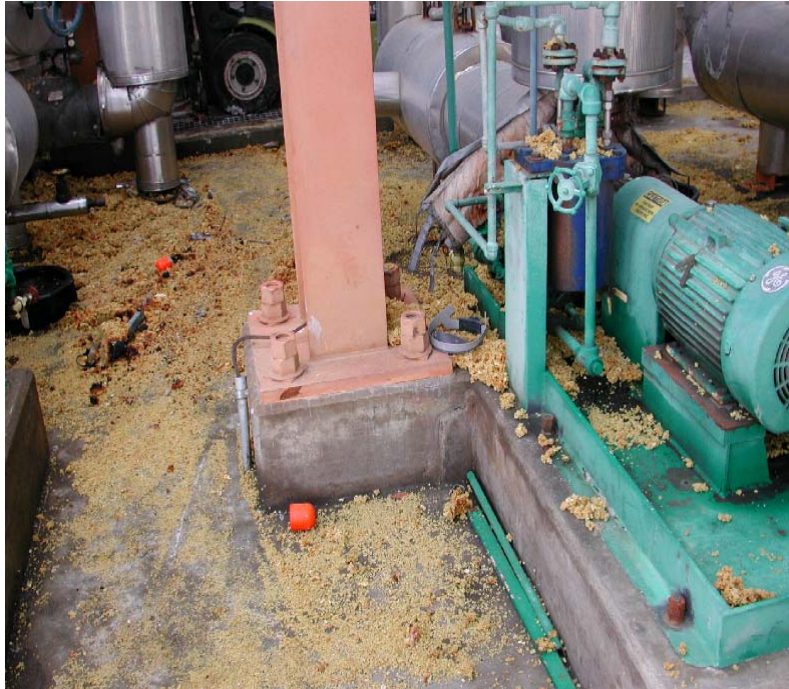
Figure A-5. Polymer scattered throughout work area.

Expelled polymer was scattered northward throughout the area, up to 70 feet from the polymer catch tank (figure A-5). Some of the polymer was charred by fire. Much of the area at grade was covered with a fine silica ash, which was determined to be a product of combustion of the heat transfer fluid that had fueled the fire. Part of the metal rack expelled from the tank was found 40 feet from the vessel, imbedded into insulation on piping to a control valve station. The control valve and piping were displaced more than 6 inches in the direction of impact.

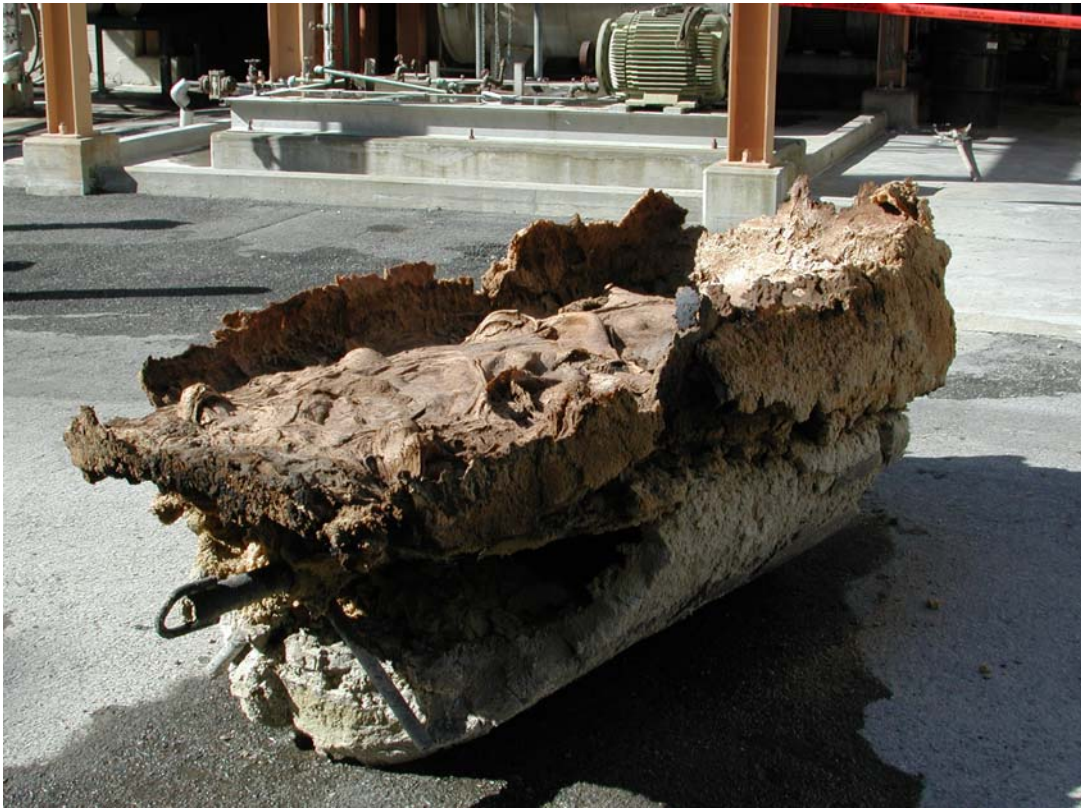
known, the liquid level in the catch tank is unknown due to uncertainties in the density of its contents.⁴⁴ Waste polymer cleaned from the catch tank on March 11, following the previous production run (Figure A-6), was composed of multiple layers of varying density, with considerable voids between layers. The waste polymer occupied 55 percent of the vessel and had a bulk density of only 3 pounds per gallon.

Figure A-6. Material extracted from the polymer catch tank on March 11, prior to the incident.

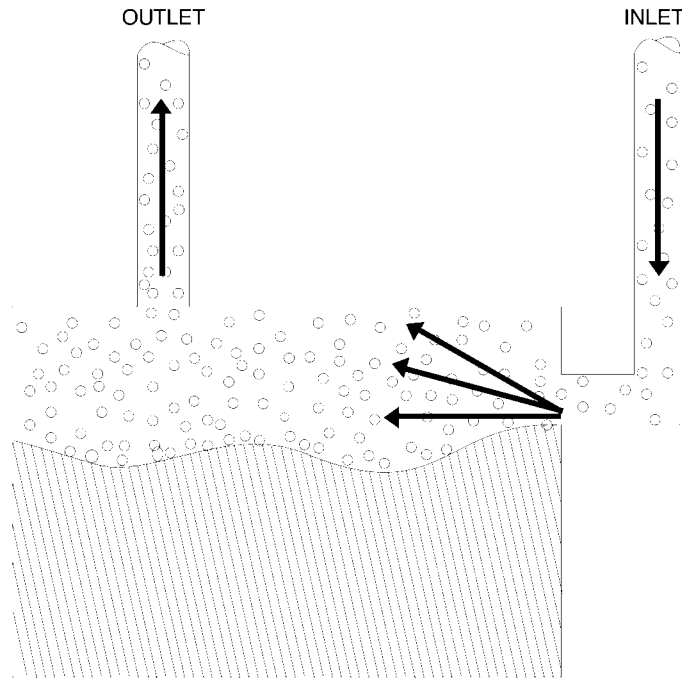
Additional vapor is generated when water and excess reactants evaporate from the melt. As the polymer catch tank filled beyond its working capacity, its ability to separate vapor from molten prepolymer degraded. Polymer droplets were entrained with the vapor stream into the vent system (Figure A-8). Once inside the vent system, polymer deposited on the piping, hardened, and restricted the flow of vapor. This activity caused the catch tank to become pressurized.

The accumulated pressure eventually exceeded the sealing capability of the cover gasket, and solvent vapor leaked from the top of the 4-foot-diameter bolted cover. Upon discovery of the leak, the solvent flow was diverted from the polymer catch tank to the reactor knockout pot—which also began to leak because significant quantities of polymer had accumulated in the common vent piping, causing the pot to pressurize. Although the vent line was restricted, it did not completely plug off at this time; flow continued through the unit. Process pressures upstream were within normal operating ranges.

Figure A-8. Polymer catch tank filled beyond working capacity—particles entrained in vent vapor.

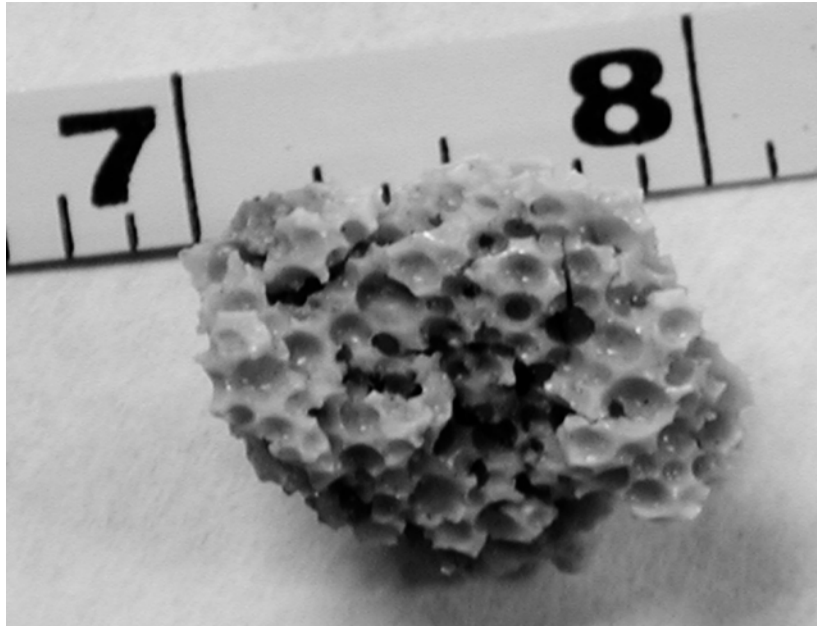
Bubbles within the expelled material caused it to have a cellular structure. Consequently, the bulk density of the material was low compared to product samples of extruded Amodel. However, the plastic encasing the individual cells was dense. It had a specific gravity of 1.1, typical of normal extruded Amodel product. The presence of bubbles within the expelled material and its cellular structure are consistent with the generation and entrapment of gas while material is in a molten state. These characteristics support the theory that decomposition and side reactions—occurring while the material was molten inside the polymer catch tank—produced gas and pressure.

Figure A-9. Sample of material expelled from polymer catch tank (note bubbles and closed cells).

The expelled plastic was yellow, though typical extruded Amodel is cream colored. The discoloration is also consistent with exposure to high temperature for an extended time.

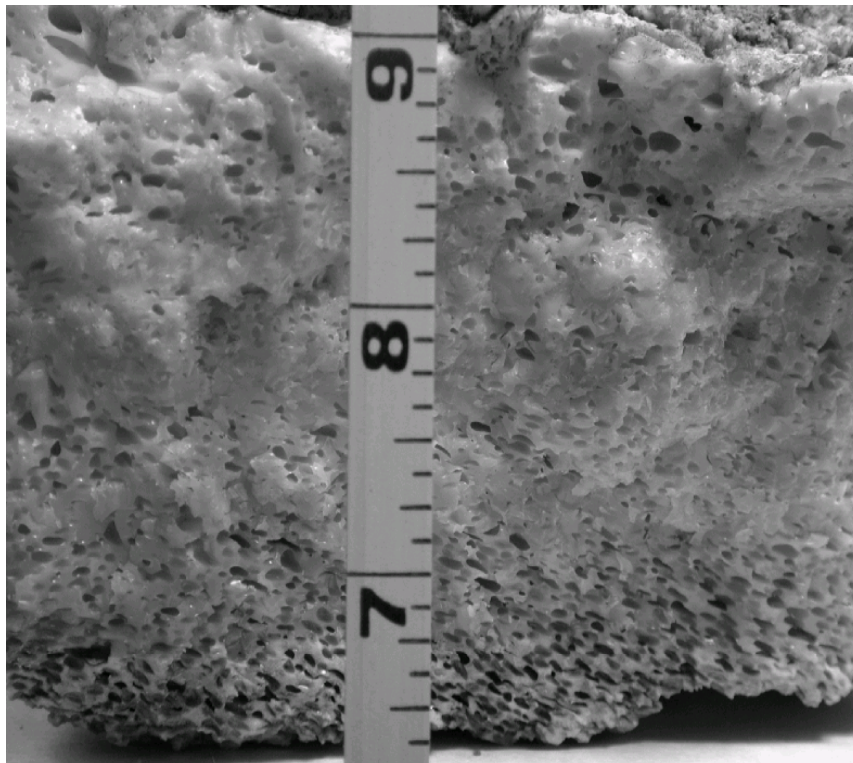
A ring of plastic 3 to 5 inches thick remained inside the polymer catch tank (Figure A-10) after the molten core blew out. The ring was generally yellow, though some of the outermost portions close to the vessel wall were cream colored. The plastic in the ring contained far fewer bubbles than the expelled material. The concentration of bubbles was greatest farther from the vessel wall, toward the core.

Heat losses that occurred through the wall of the polymer catch tank from the time it was filled until it was opened likely explain why the material adjacent to the vessel wall solidified by the time workers started removing the cover. This explanation is also consistent with the observation that cream-colored polymer was prevalent along the outermost perimeter of the ring. Because it was close to the

Figure A-10. Layer of hardened polymer taken from inside perimeter of polymer catch tank

vessel wall, this material cooled sooner and was less susceptible to side reactions and thermal decomposition.

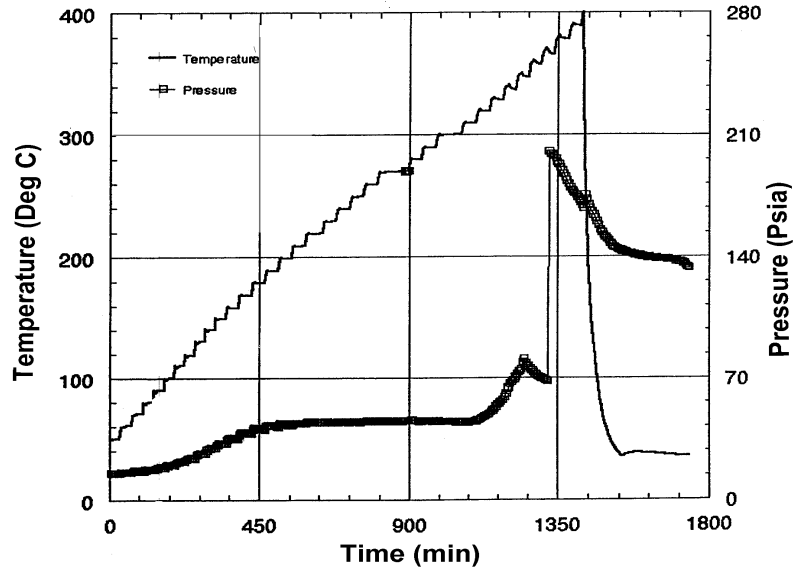
Figure A-11. ARC data for Amodel.

Two runs were also performed on a different grade of Amodel. In both of these tests, pressure initially increased at 330°C. In one test, there was a rapid rise in pressure at 370°C; in the other, pressure increased suddenly at that temperature but less rapidly. The pressure peaked at 4.5 times the initial pressure in one test and at 4.4 in the other. The reaction process was endothermic. Figure A-11—from the company's internal investigation report—depicts temperature and pressure data from the first test.

The ARC data fully support the conclusion that the plastic decomposes. The lower onset temperature for the pressure rise observed in the tests on one grade of Amodel indicates that it is more susceptible to decomposition than the other grade.
