U.S. CHEMICAL SAFETY AND HAZARD INVESTIGATION BOARD

INVESTIGATION REPORT

CATASTROPHIC VESSEL OVERPRESSURIZATION (4 DEATHS)

Sonat Exploration Company
Temple 22-1 Common Point Separation Facility
Pitkin, Louisiana
March 4, 1998

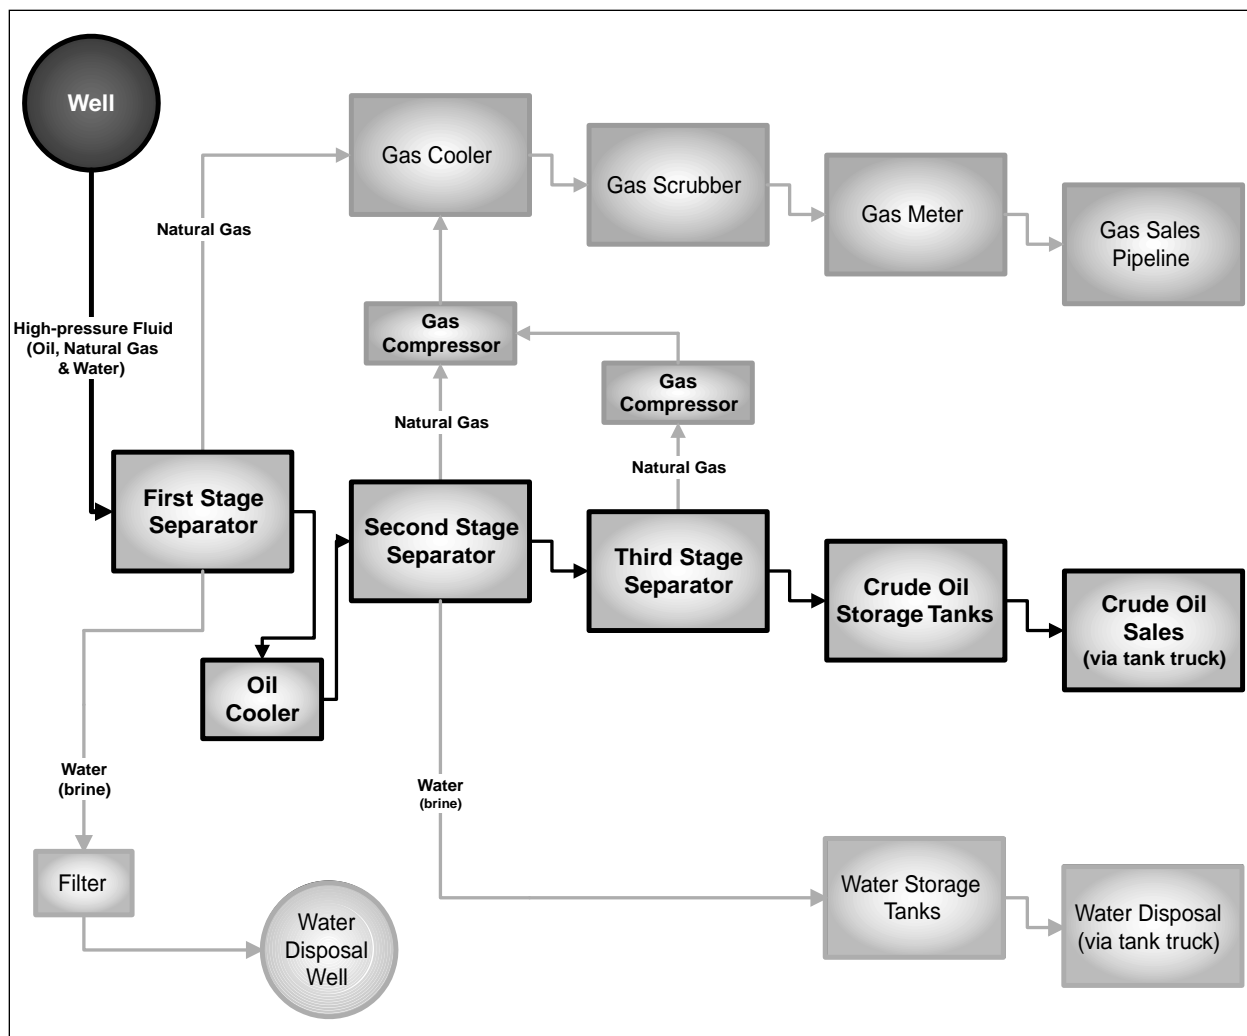
Figure 2. Block Flow Diagram of the Separation Process

on each separator. Actual operating pressures were considerably lower, around 900 psig for the first-stage separator and 225 psig for the second-stage separator. The third-stage separator¹⁶ had an MAWP of 0 psig (atmospheric pressure) and would have operated around this pressure during normal operation. As the pressure of the well fluid was decreased through the series of separators, the solubility of natural gas in the fluid decreased and an increasing fraction of the gas would distill off for collection.

The first two separators were designed for three-phase (gas/oil/water) separation, while the third-stage separator was designed for two-phase (gas/oil) separation. Residence time of the fluid in the first two separators was sufficient for the gravity-based separation of the oil and water phases. Natural gas from the separators was directed to the gas sales pipeline, while separated brine was either directly injected into the ground or impounded in storage tanks. The oil phase was transferred from one separator to the next, and eventually to the storage tanks for shipment by truck to a refinery. Natural gas was compressed and transported by pipeline to a gas processing plant. Figure 3 shows the overall layout of the facility.
