INVESTIGATION REPORT

THERMAL DECOMPOSITION INCIDENT

BP AMOCO POLYMERS, INC.

REPORT NO. 2001-03-I-GA

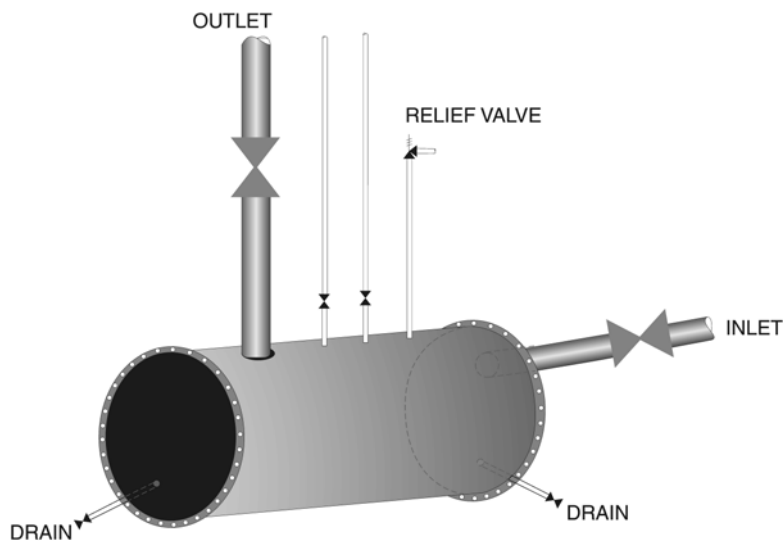
Figure 2. KD-502 polymer catch tank (simplified representation).

During normal process operation, the prepolymer produced in the reactor is fed to the extruder. During periods of startup and shutdown, and when there are mechanical difficulties with the extruder, the reactor effluent is diverted to a waste collection vessel—referred to as the polymer catch tank (Figures 2 and 3). The catch tank is a 750-gallon horizontal cylindrical steel vessel with a flat cover bolted to each end. Before startup, it is empty except for a removable branched metal frame that serves as a surface on which polymer agglomerates.

The polymer catch tank serves as a chamber for separating prepolymer from vapor. The rapidly flowing process stream from the reactor enters the catch tank through a 4-inch pipe nozzle located on one of the end covers. The velocity of the stream decreases as it enters, causing liquid droplets of polymer to fall and settle inside the vessel. The prepolymer accumulates in the vessel; the vapor portion of flow exits through a 6-inch vent nozzle located on top of the cylindrical shell.

Three other piping connections are located on top of the polymer catch tank. One is used for the pressure relief device. The other two are utility connections for nitrogen and service water, which can be used for purging and flushing the vessel.

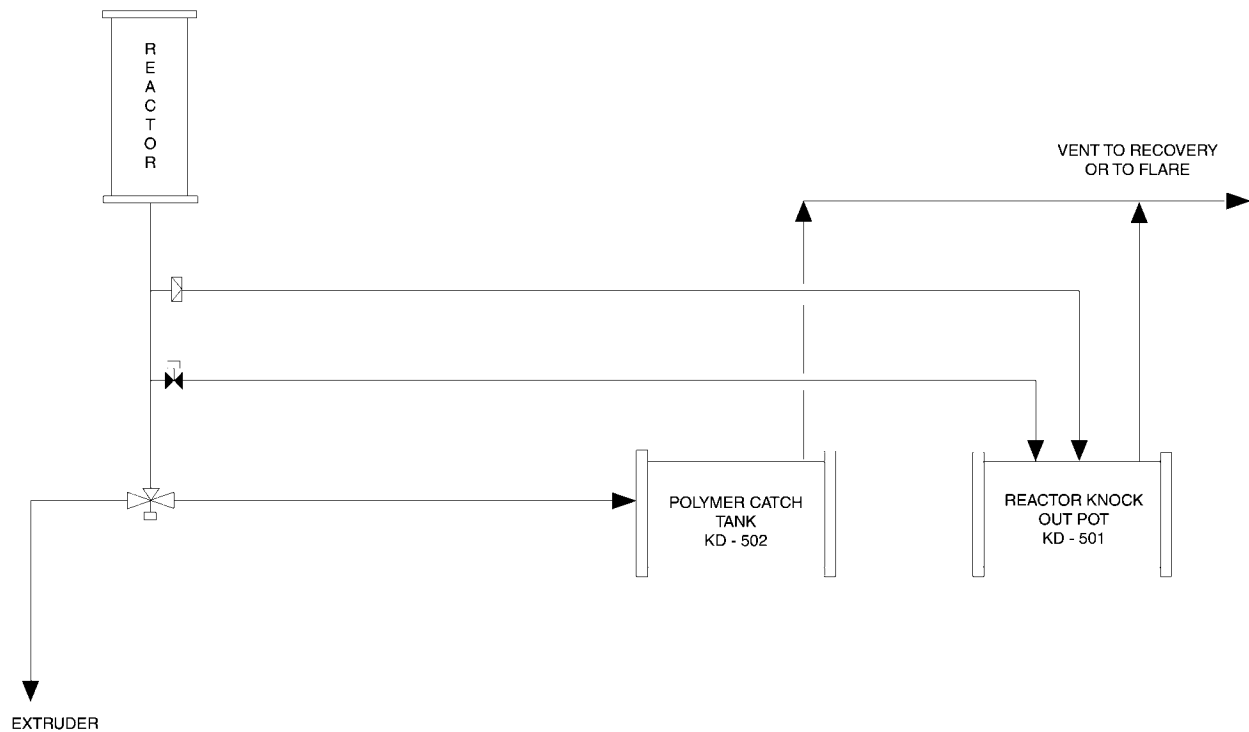
Figure 4. Simplified process diagram showing polymer catch tank and reactor knockout pot.

Typically, during startup of the process, the effluent from the reactor is directed to the polymer catch tank for 50 minutes¹² before being diverted to the extruder (Figure 4). Prepolymer that accumulates inside the catch tank during startup normally cools and solidifies.

The reactor knockout pot (KD-501) is another waste vessel very similar in design to the polymer catch tank. Figure 4 depicts its arrangement and connectivity to the process. The emergency pressure relief devices at the outlet of the reactor discharge to the knockout pot. The reactor effluent can be directed to the knockout pot when the catch tank is too full.
